Science Flight Report

Operation Ice Bridge Fall 2009

Antarctic Flight No 18
Mission Plan: Abbot Ice Shelf 1

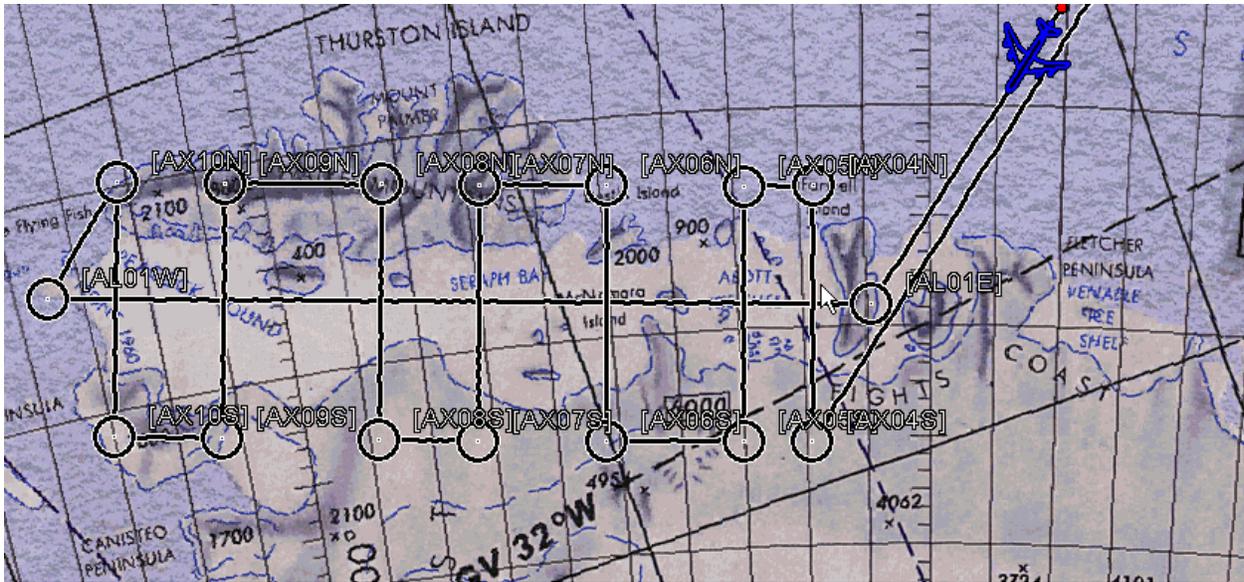
Figure 1: Waypoints and survey area of Flight 18 – Mission ID Abbot 1.

14:09:27 Zulu: takeoff
 17:13:45 Zulu: begin descent into survey area
 17:35:34 Zulu: start of first survey line at waypoint AL01E
 21:27:20 Zulu: end of last survey line at waypoint AX04S, starting to climb
 00:22:06 Zulu: ramp over flight at Punta Arenas airport for ATM boresight alignment
 00:30:13 Zulu: touchdown
